# WOOD DESTROYING PESTS AND ORGANISM INSPECTION REPORT

Building No.	Street	City	ZIP	Date of Inspection <b>1/15/2008</b>	Number of Pages <b>Page 1 of 4</b>

<b>58 Wright Brothers Ave</b> <b>Livermore, CA 94551</b> <b>(925) 294-1800 • Fax (925) 294-1816</b> <b>Registration # PR1452</b>			HomeGuard Rpt #: <b>064257</b>	
Ordered By: <b>Ken Jacobs</b>		Property Owner/Party in Interest		Report Sent to:      Escrow#:		
COMPLETE REPORT <input checked="" type="checkbox"/>		LIMITED REPORT <input type="checkbox"/>		SUPPLEMENTAL REPORT <input type="checkbox"/>		
REINSPECTION REPORT <input type="checkbox"/>		General Description: <b>One story single family residence with a wood siding and brick veneer exterior, excluding the wood decks.</b>				
				Inspection Tag Posted: <b>Garage</b>		
				Other Tags Posted: <b>None noted</b>		
An inspection has been made of the structure(s) shown on the diagram in accordance with the Structural Pest Control Act. Detached porches, detached steps, detached decks and any other structures not on the diagram were not inspected.

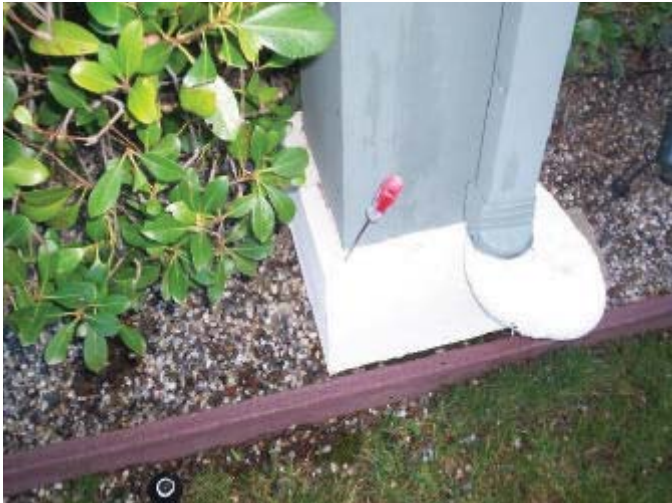
Picture 1

**1A. FINDING:** The trim has been damaged by fungus at the front overhang column. (See Picture 1)  
**RECOMMENDATION:** Remove and replace all the damaged wood members. If any damage is found to extend into any enclosed areas a supplemental report and bid will be issued.  
 \*\*\*\*\*(SECTION 1 ITEM)\*\*\*\*\*

1A     \$275     **Total**     **\$275**
